Enhanced Reclamation Program

Presented By:
Stephanie Tomkinson
Senior Biologist
October 14, 2010

QEP Energy Company

Environmentally Friendly Drilling (EFD) Workshop

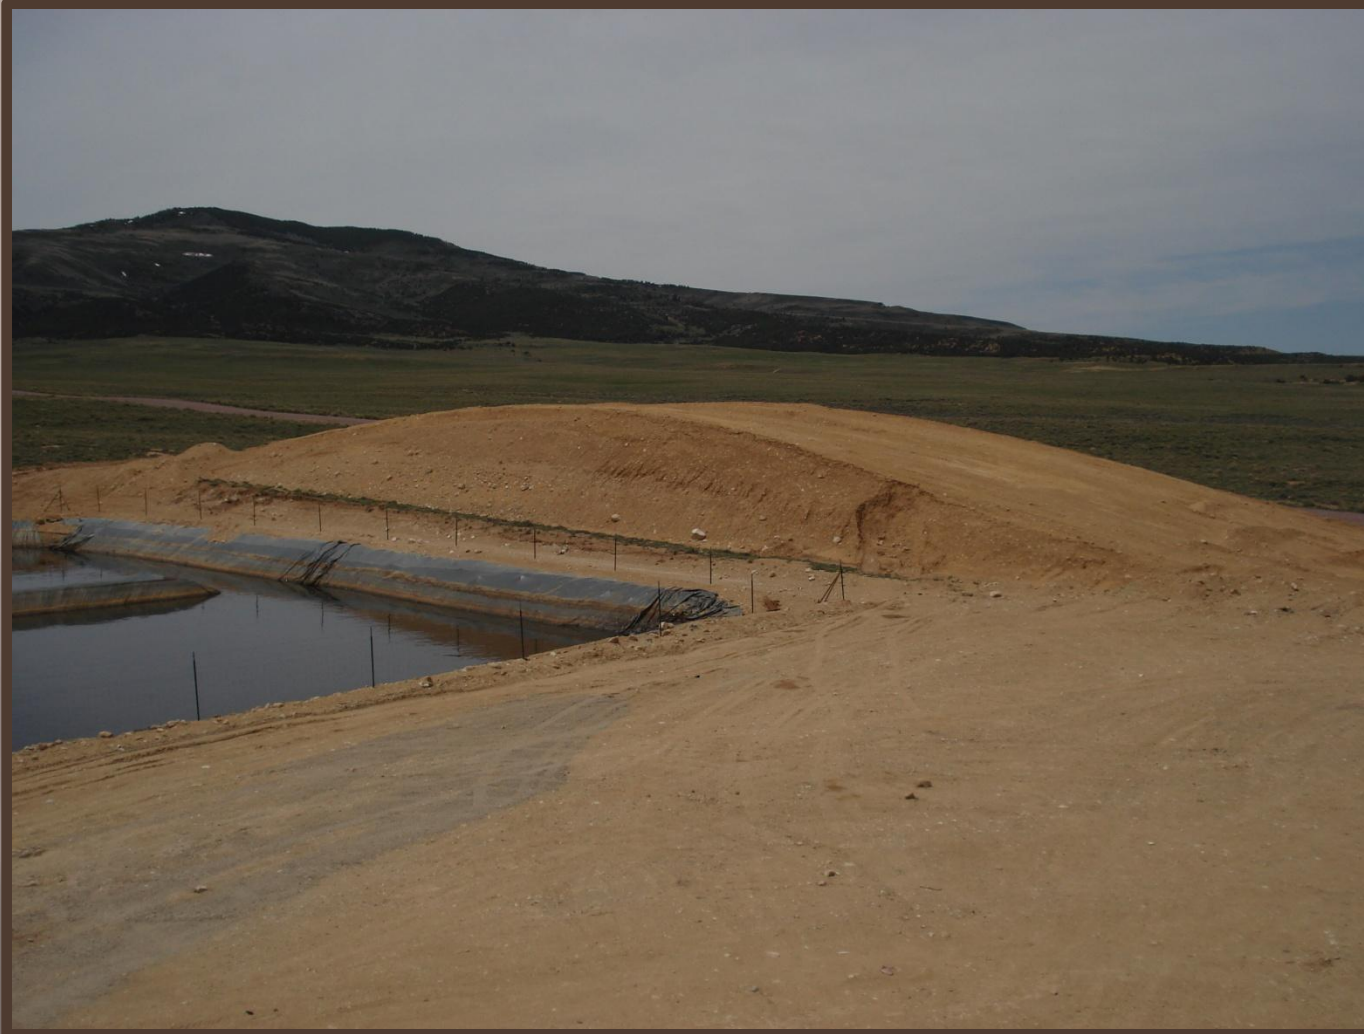
- Empty and backfill reserve pit

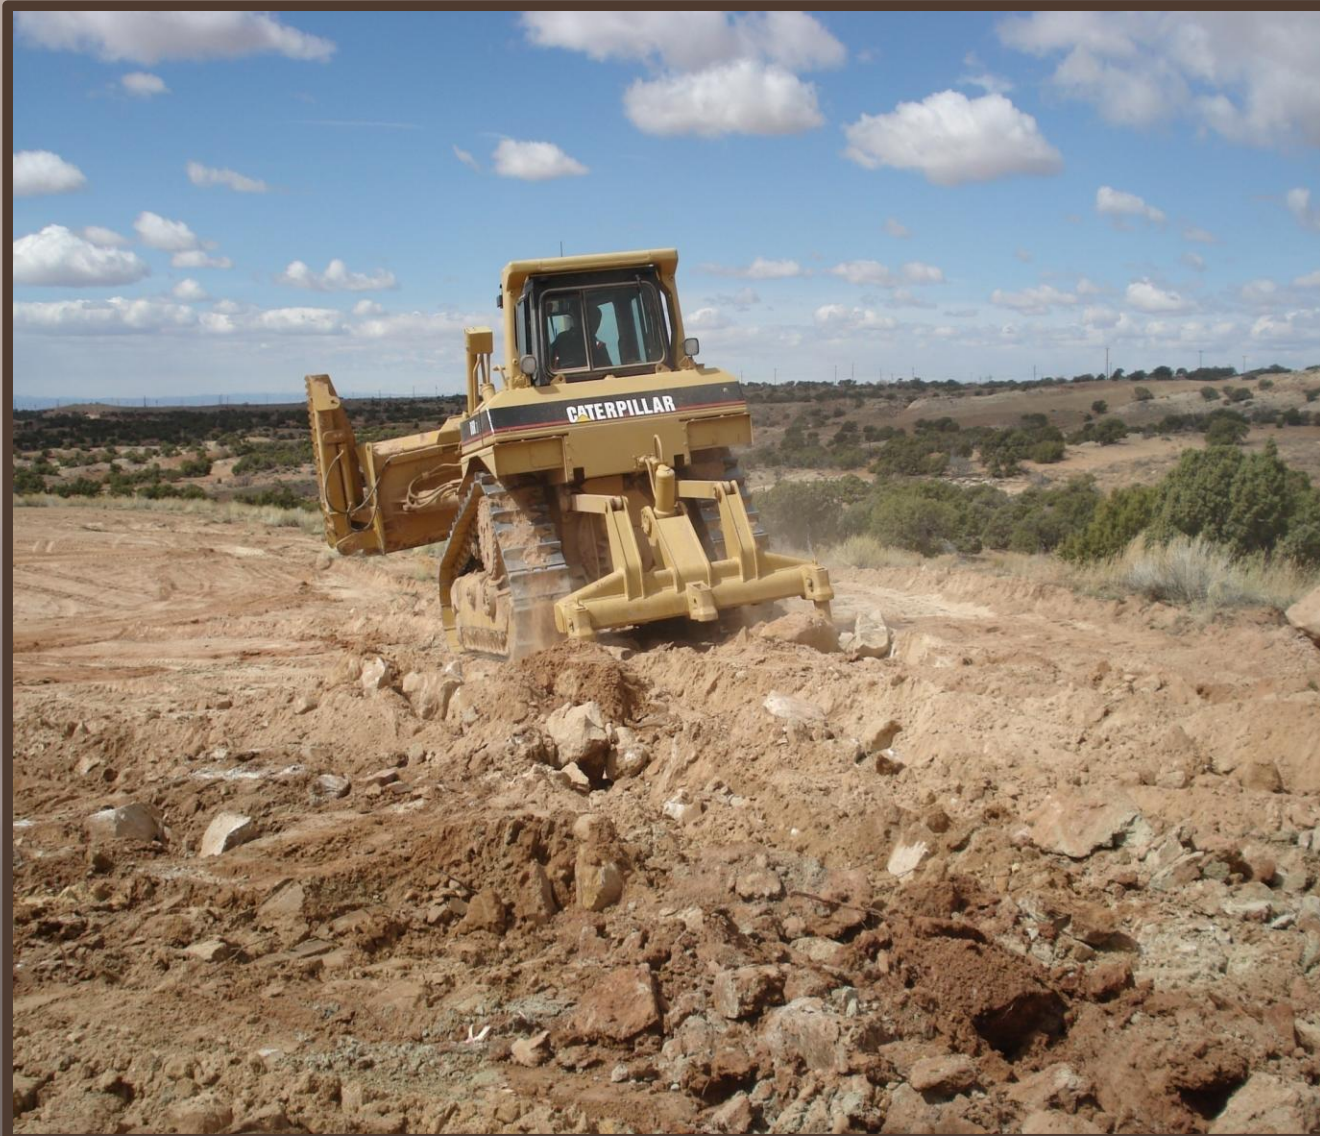
- Rip to relieve compaction

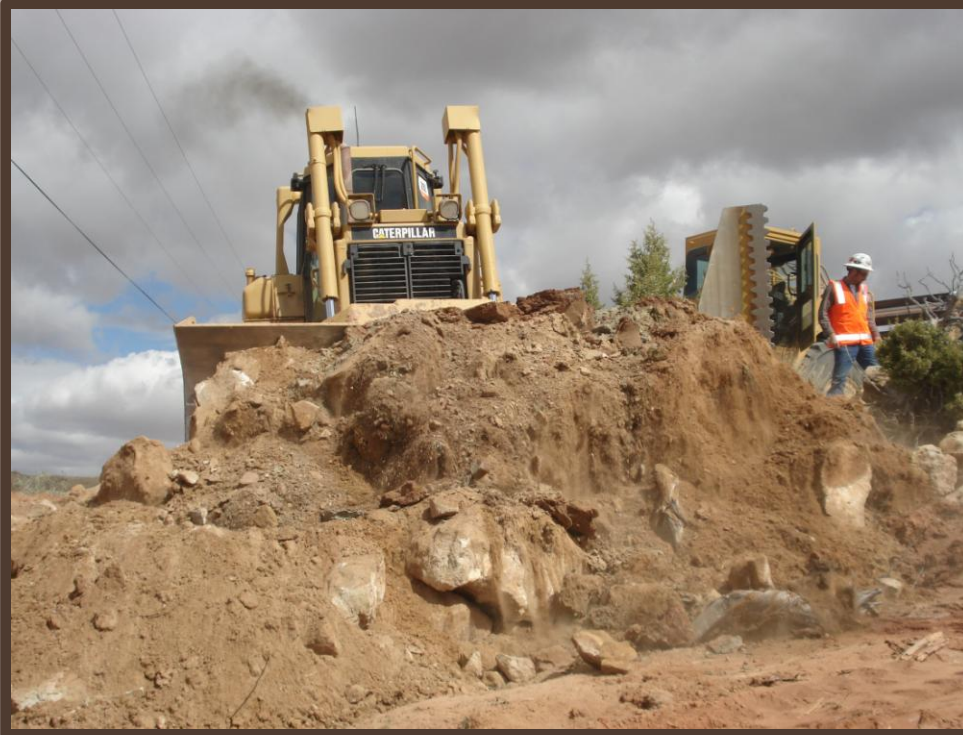
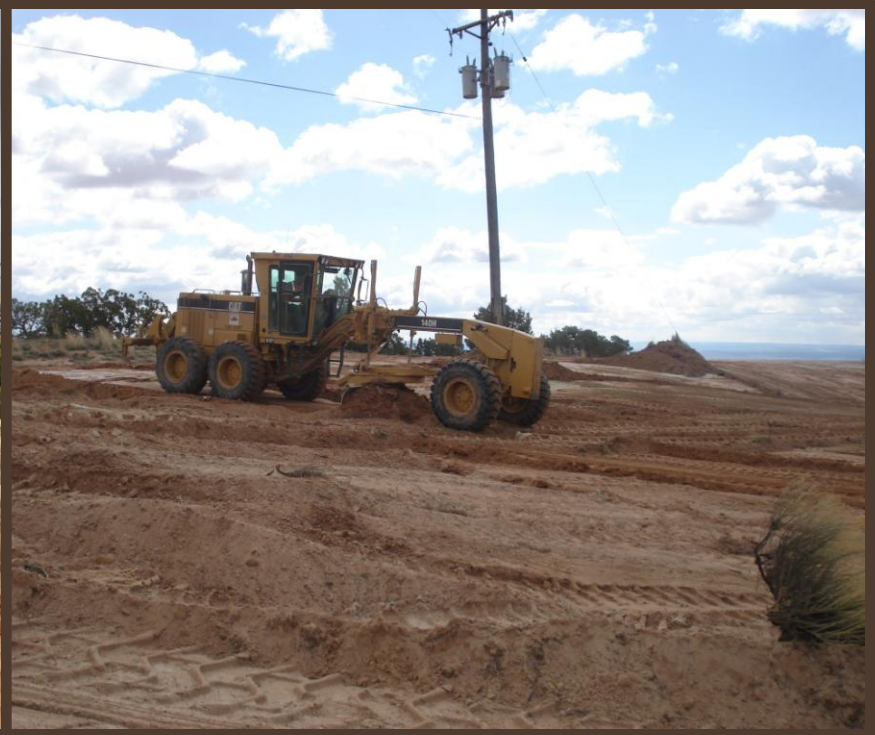
- Recontour

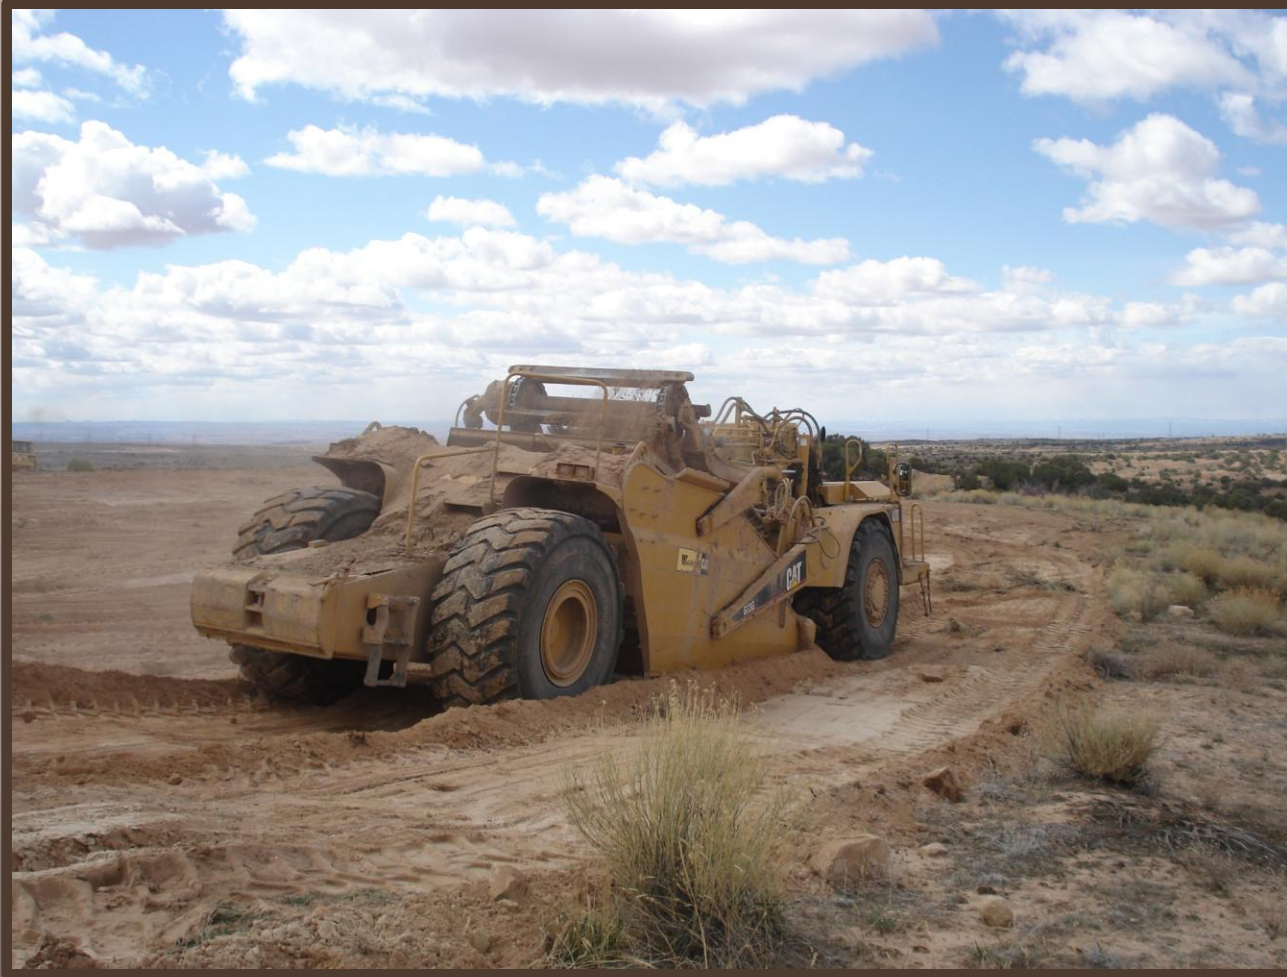
- Spread topsoil

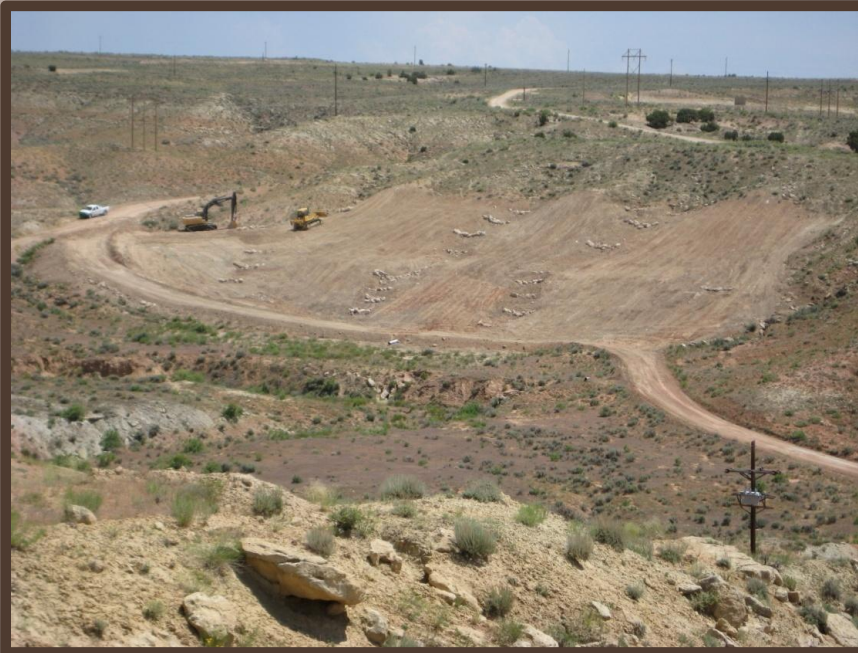
RW 14-20B

- Establish drainage

Plugged and Abandoned June 2008

Reclaimed Fall 2008

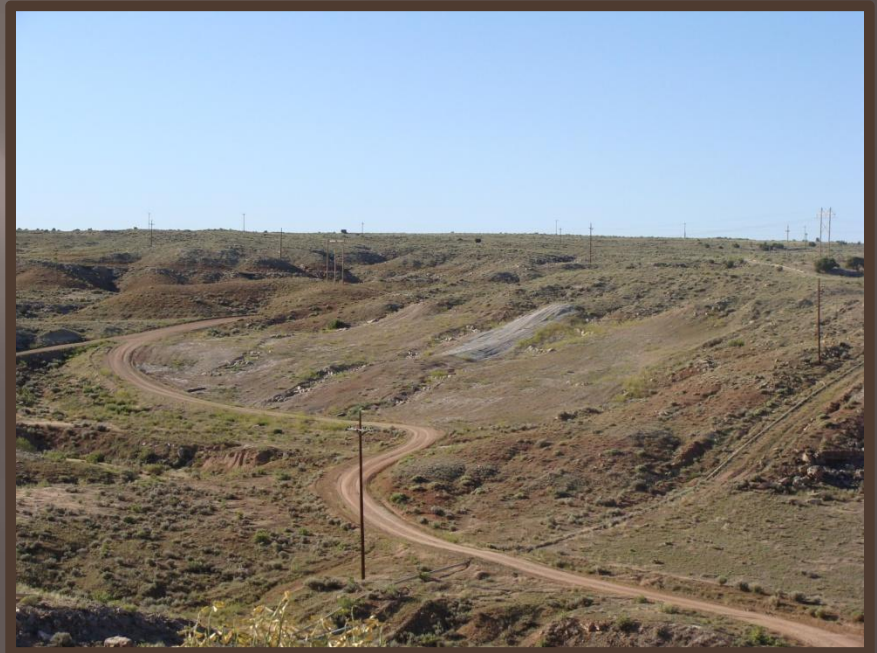
RW 14-20B

July 6, 2010 2nd Growing Season

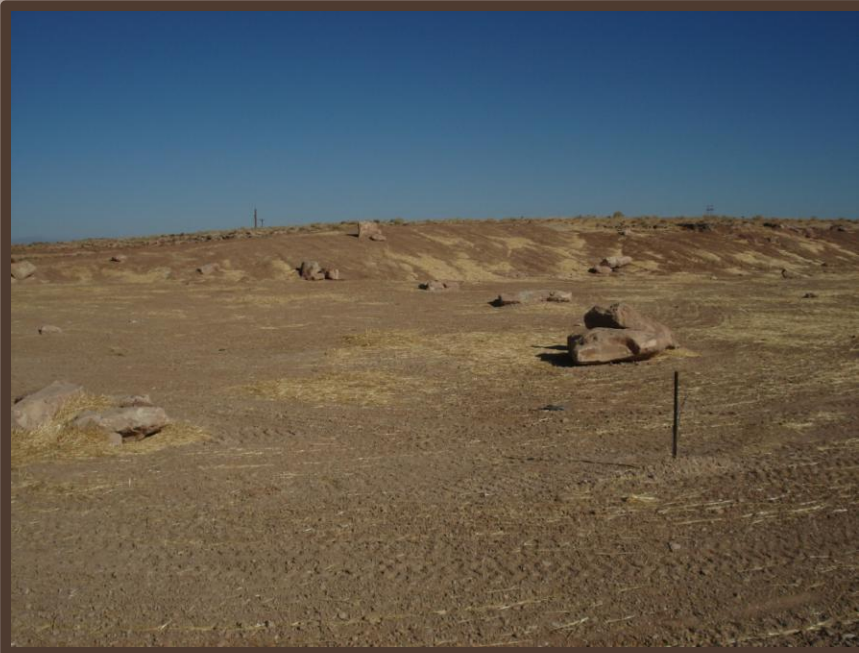
RW 34-27ADR , Red Wash Field, Uintah County, Utah

Carefully and strategically placed shot rock and juniper litter.

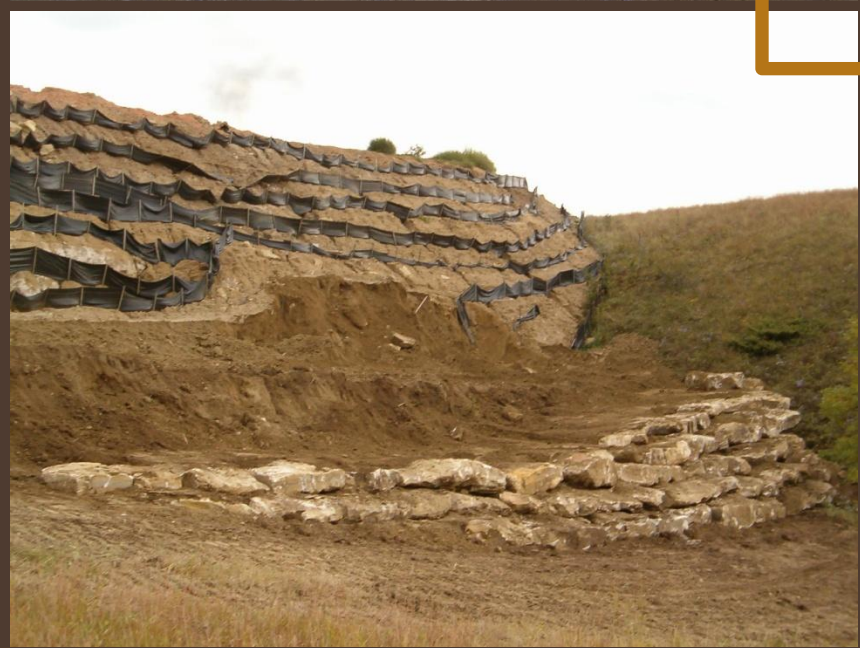
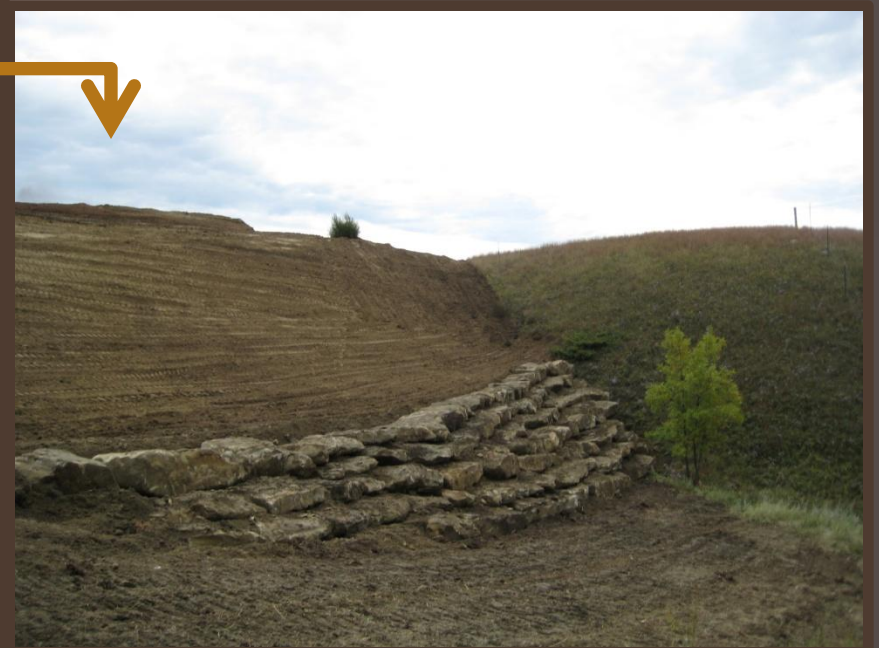
SCT 6G-12-7-22

P&A Location - Reclaimed 6/2008

Photographed 6/2009 - 1 Growing Season

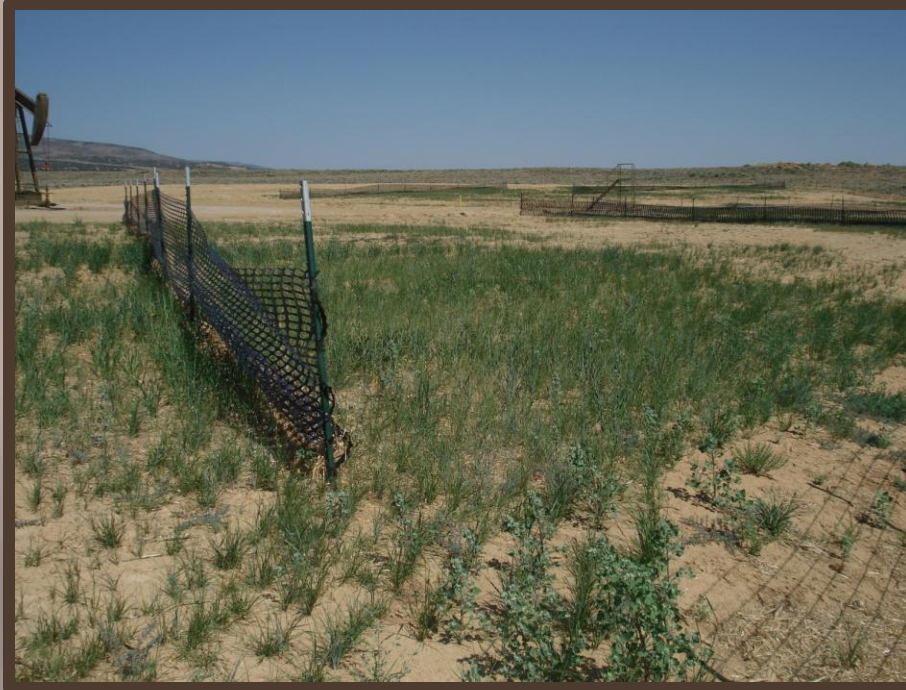
Sparks Ridge 1: July 8, 2008

1st growing season - effects of snow fence

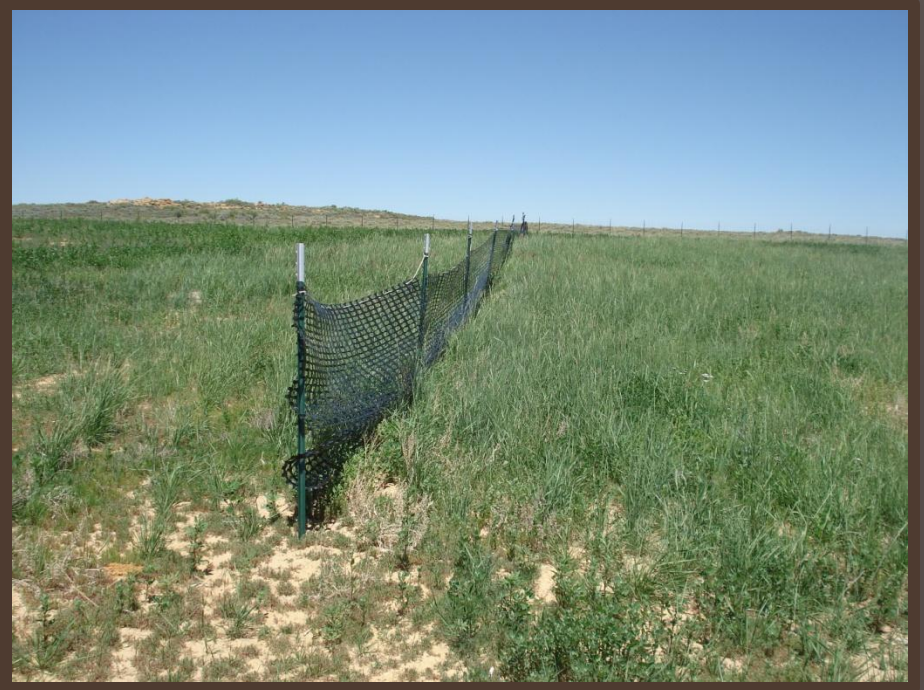
Sparks Ridge 1: June 23, 2009

2nd growing season - effects of snow fence

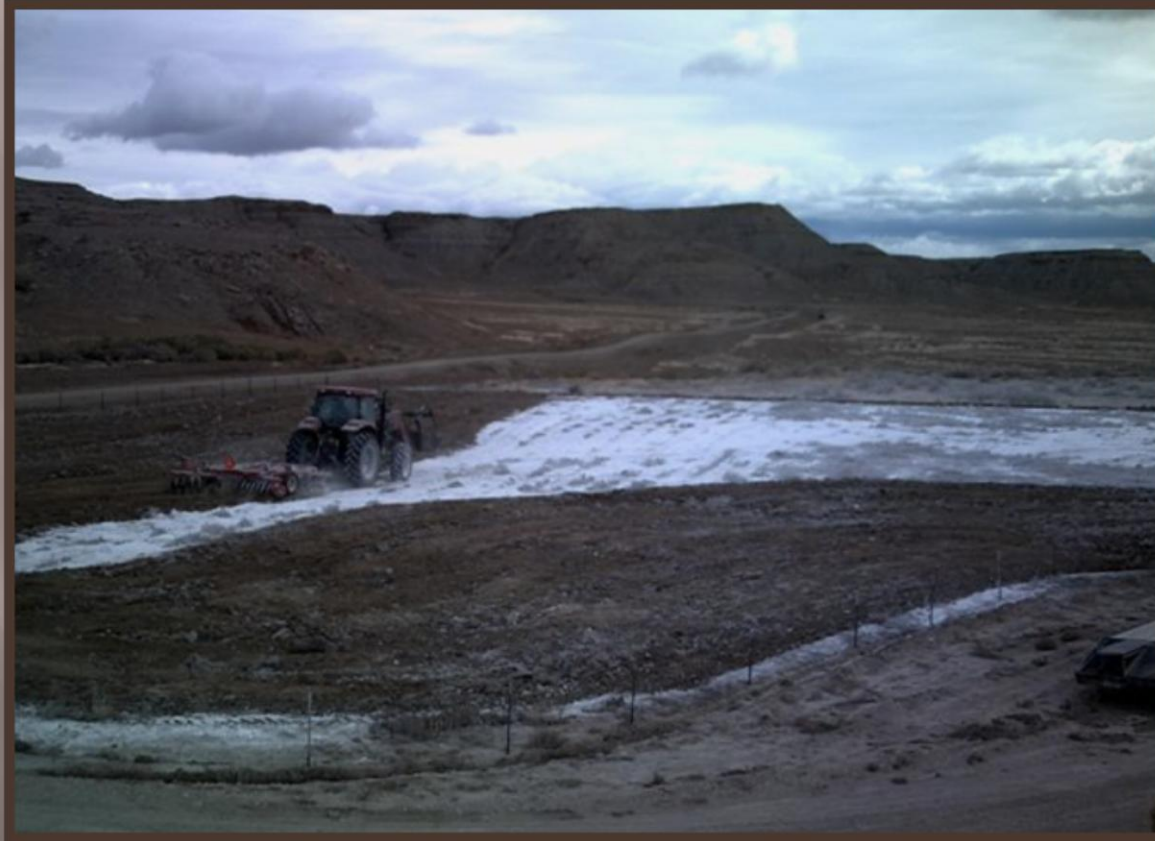
Soil Amendment: Gypsum

Disced into top 3" of soil.

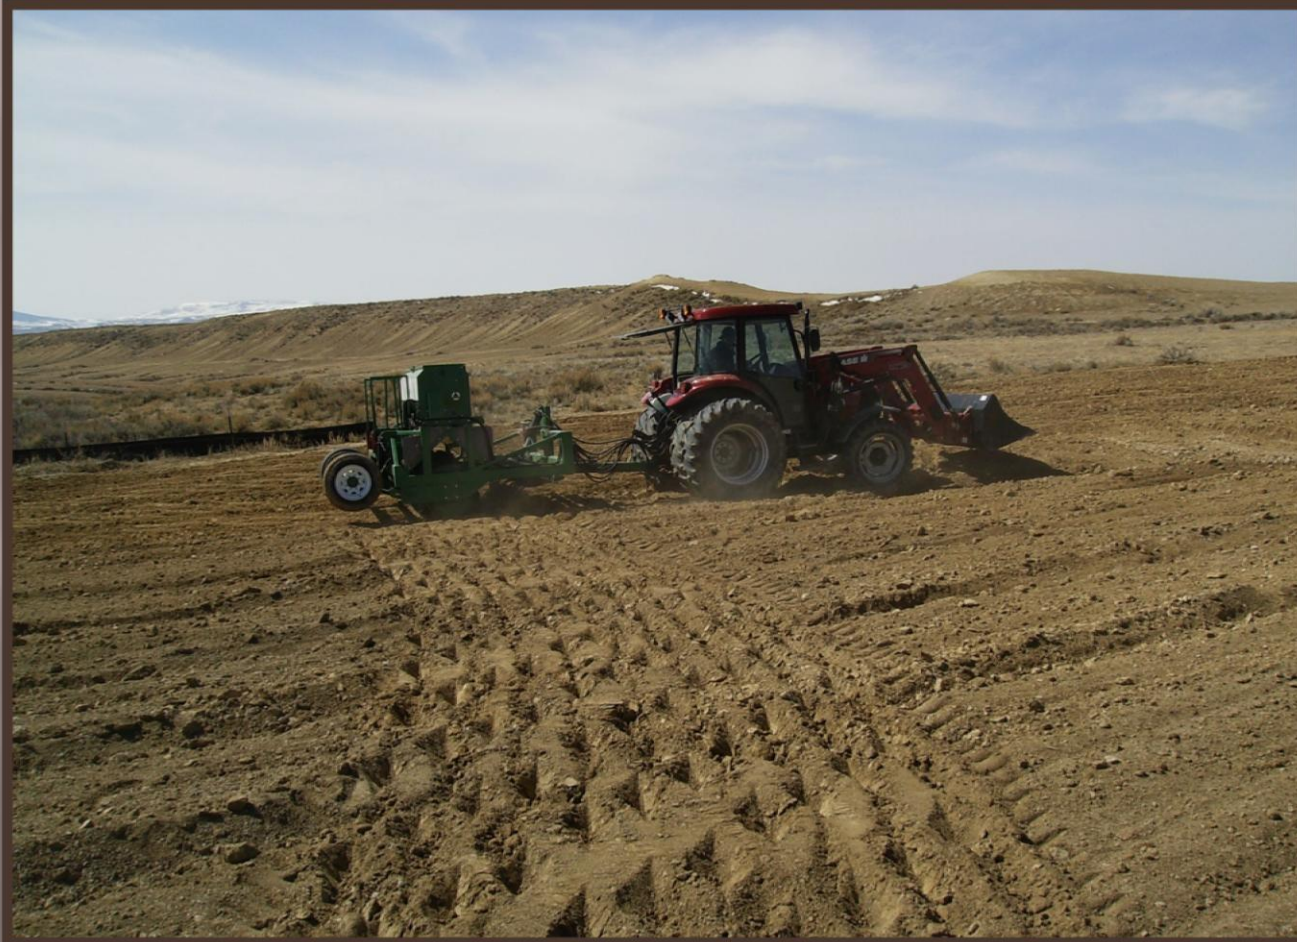
Imprinting

Moisture retention and erosion control.

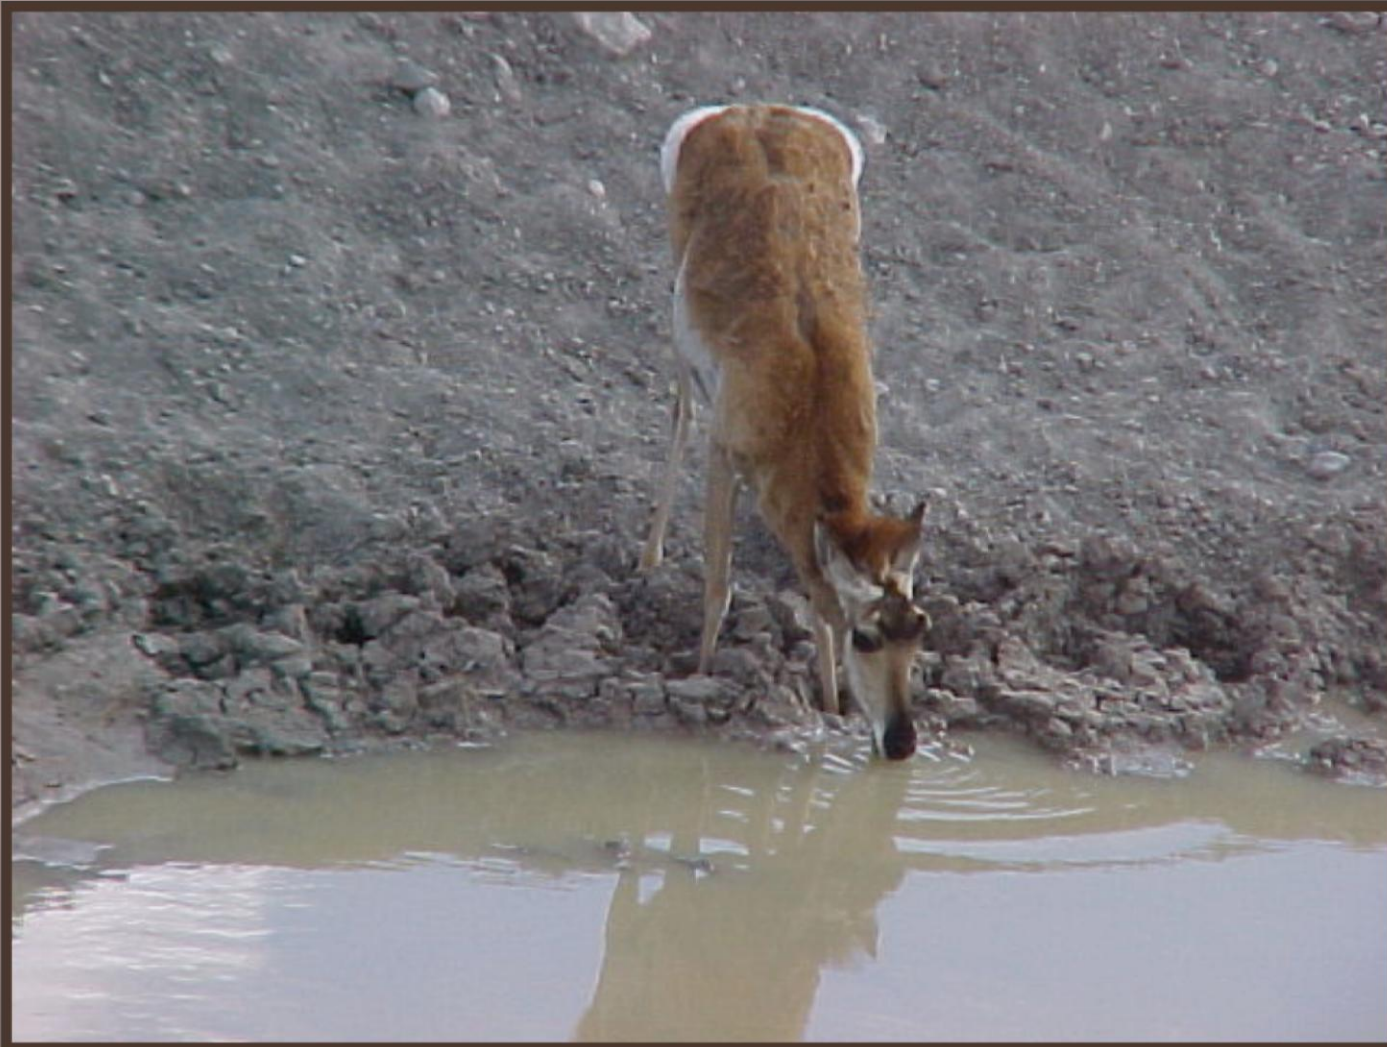
Ponds

Ponds built while reclaiming locations.

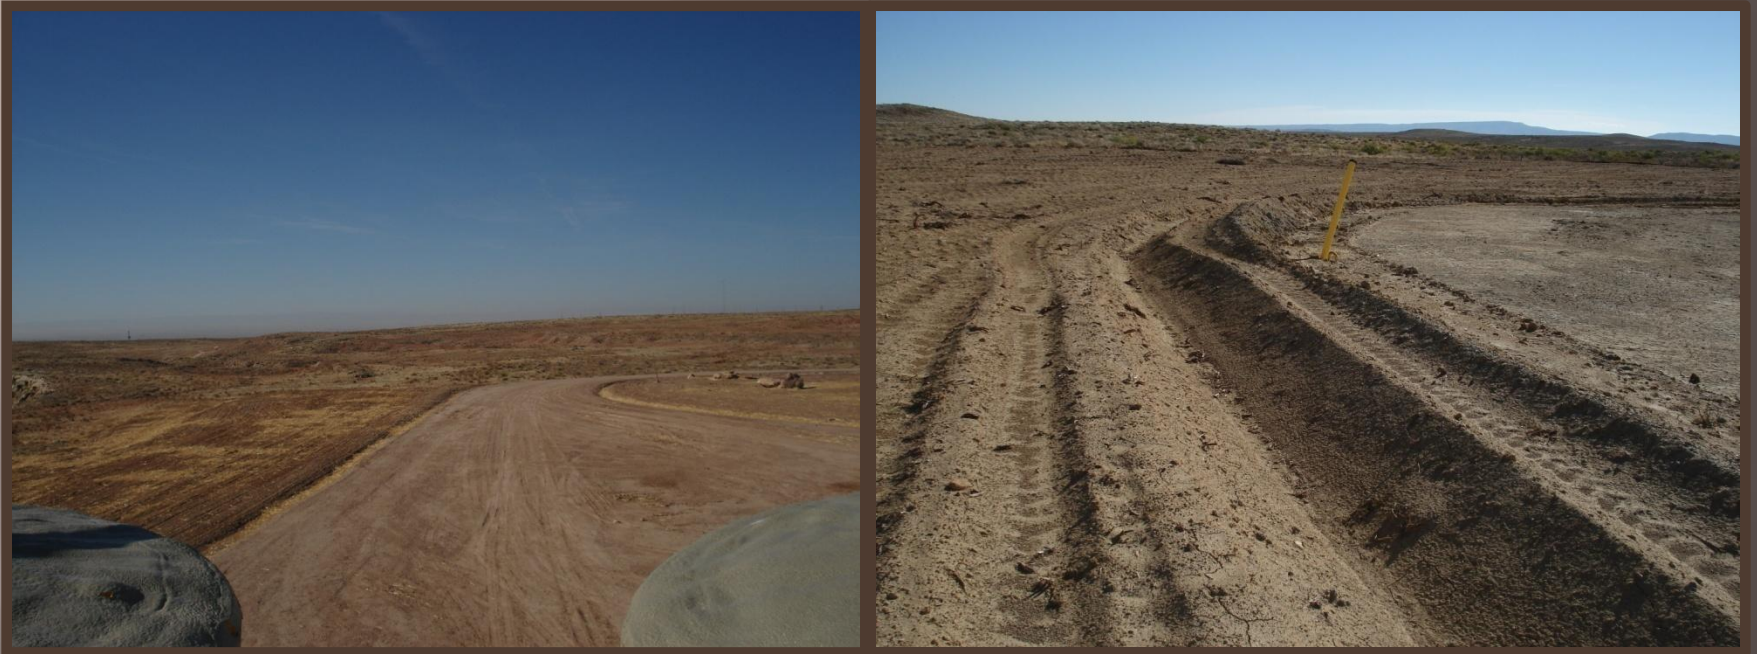
RW 34-27ADR , Red Wash Field, Uintah County, Utah

Ditch Perimeter of Production Pad
